PERATION

GREENHOUSE

SCIENTIFIC DIRECTOR'S REPORT

ANNEX 3.2 U. S. NAVY STRUCTURES

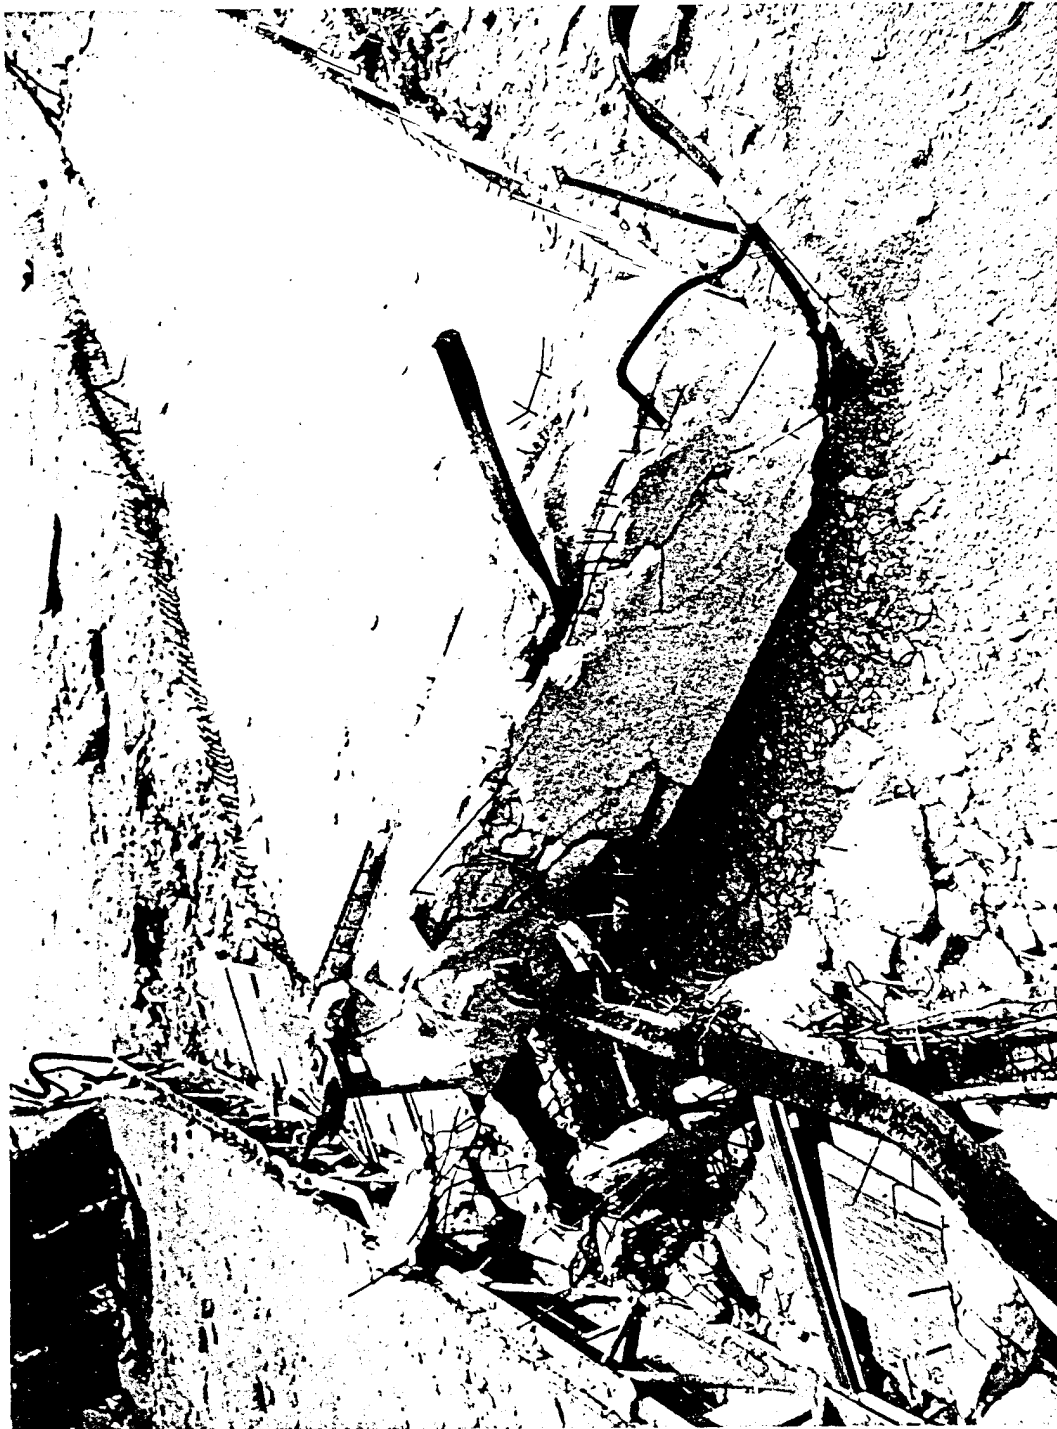
Fig. L. 259 Detail View of Underside of Front Edge of Roof, Structure 3, 2.3b. Note how ends of trusses have pulled out.

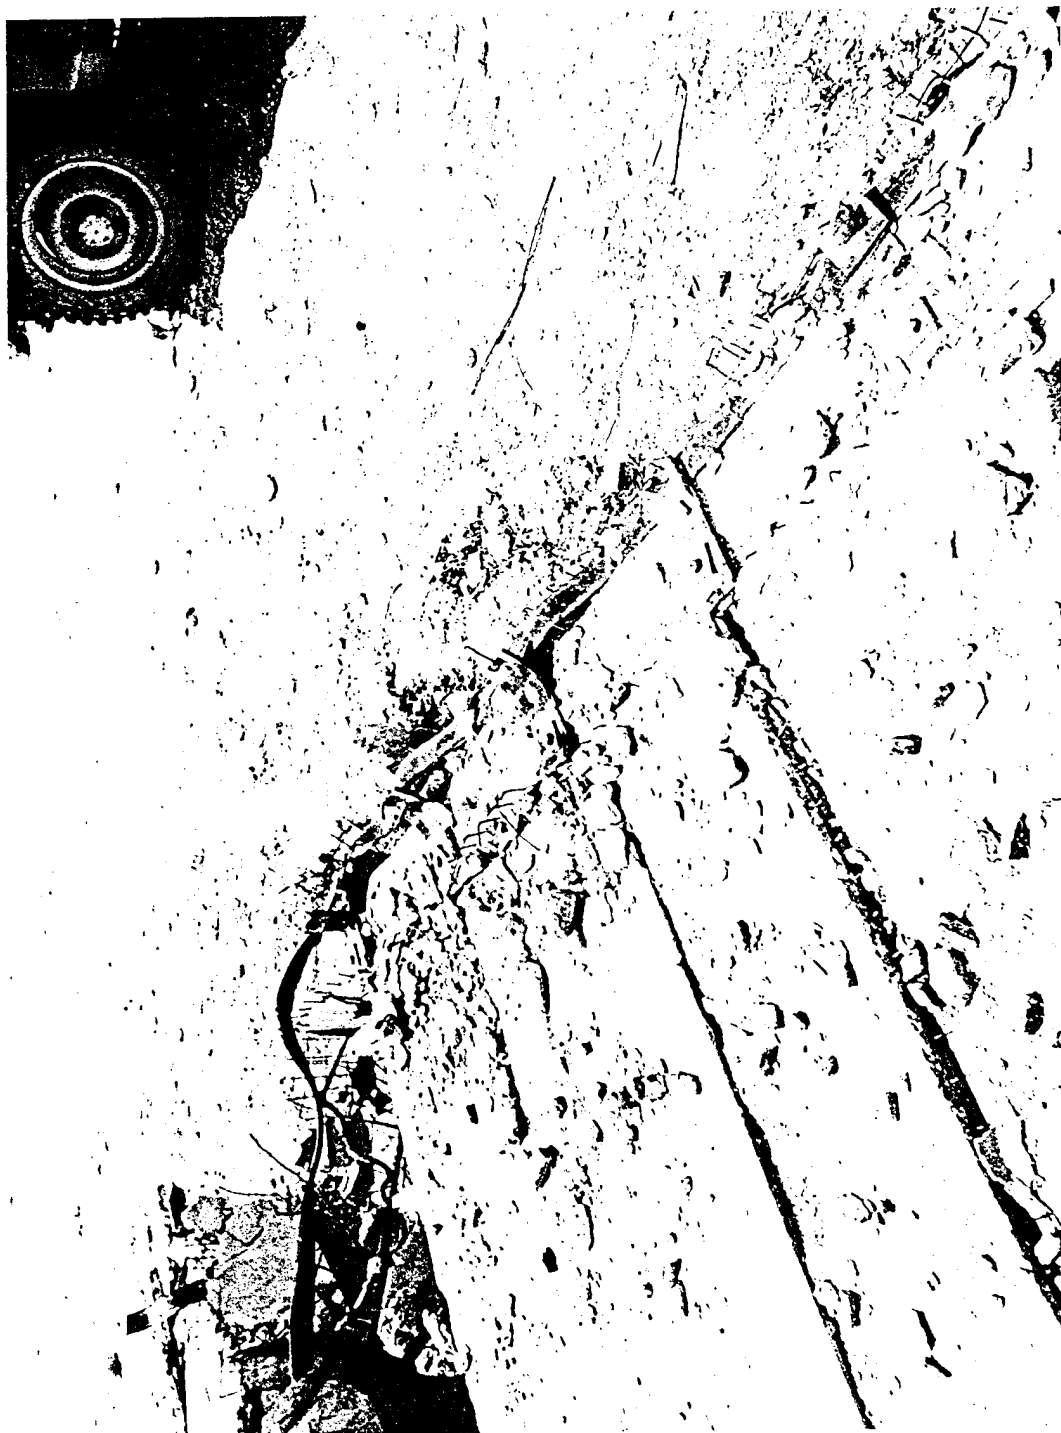
Fig. L. 260 Detail View of Front Edge of Roof Panel, Structure 3. 2. 3b. Note breaks in the edge truss main bars.

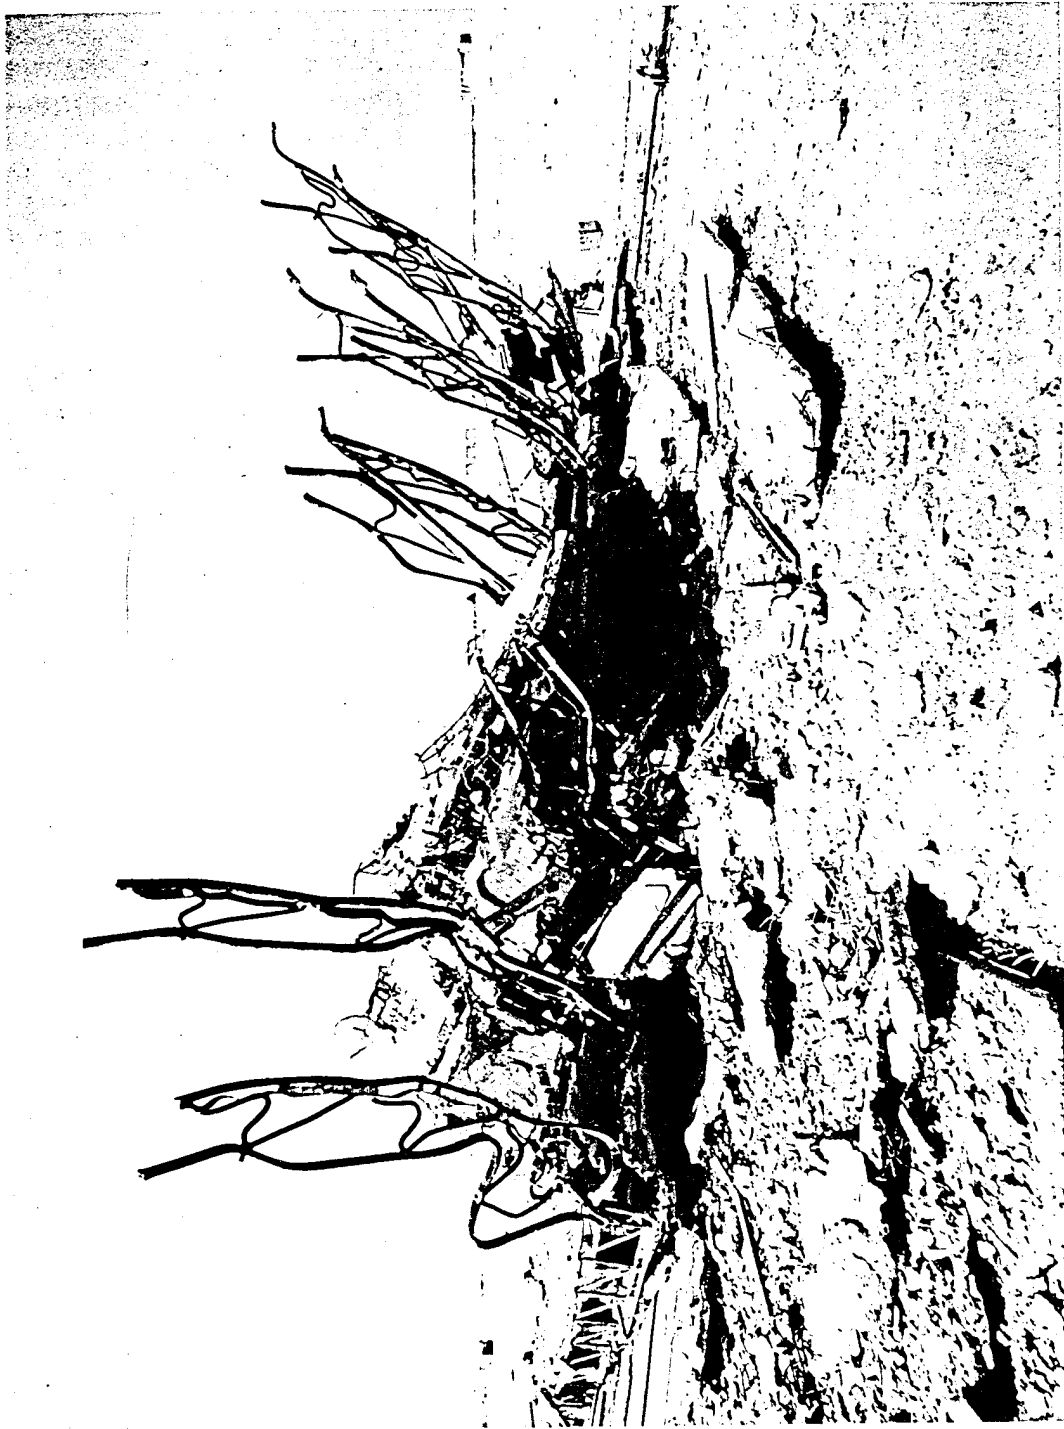
Fig. L. 262 Edge View of Roof Panel That Split along a Line of Cells, Structure 3. 2. 3b

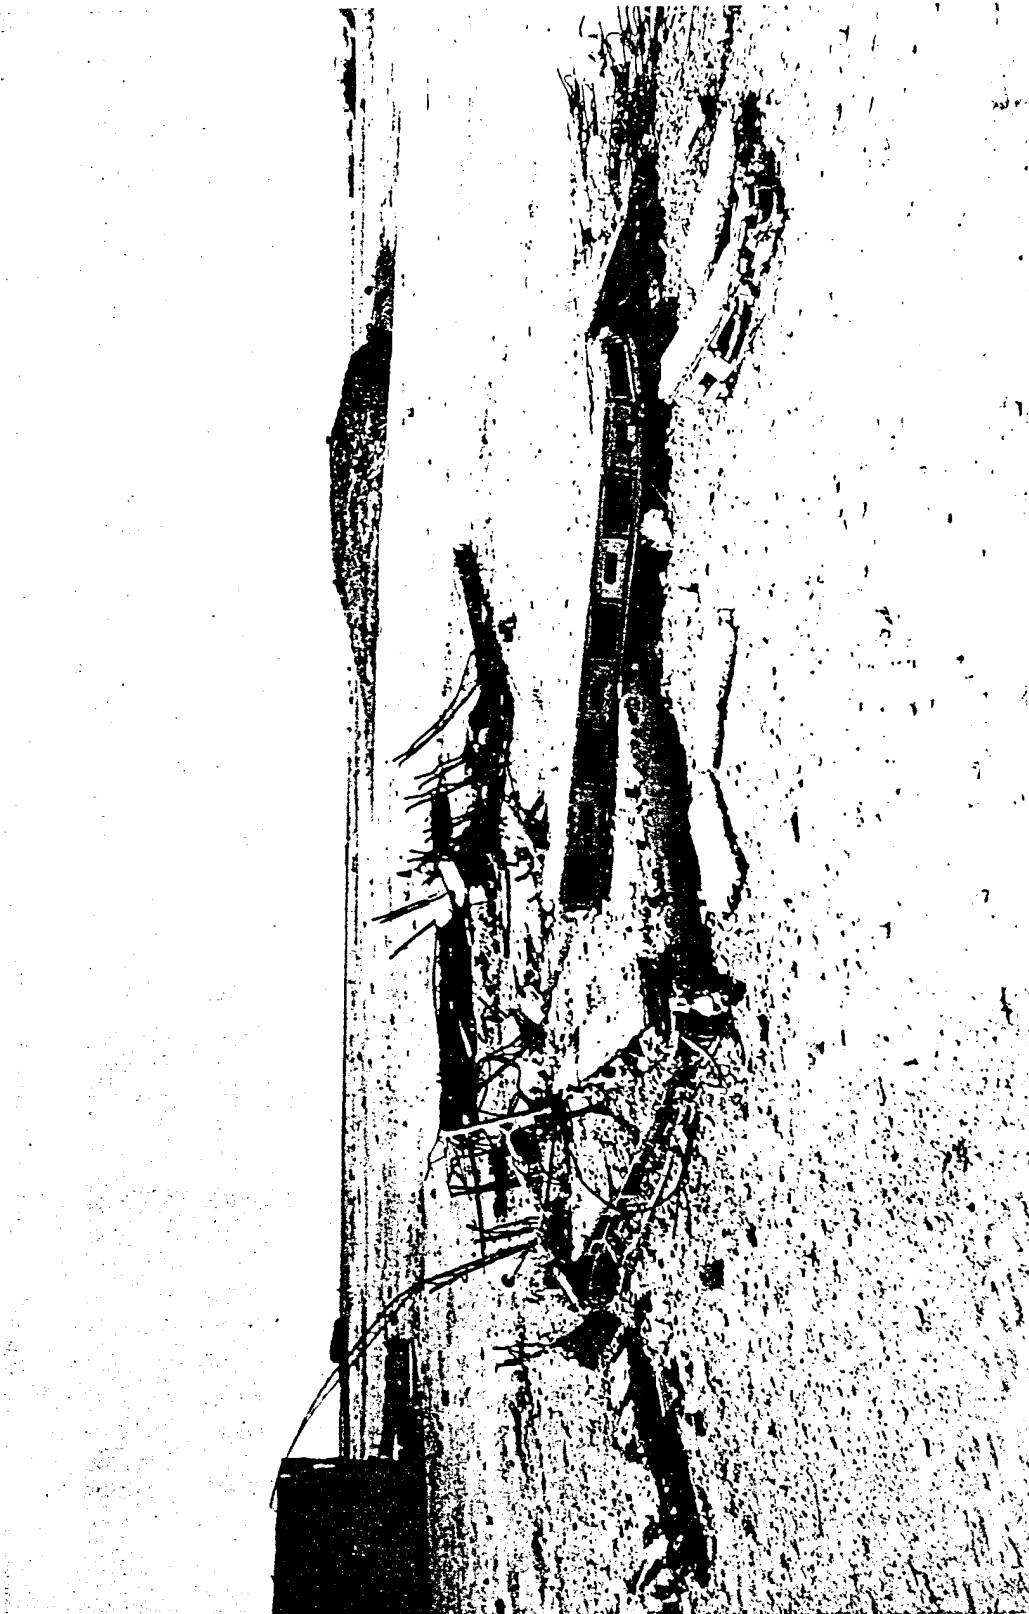
Fig. L. 263 Rear Edge of Left Half of Roof, Structure 3.2.3b. This crushing and severe distortion was undoubtedly caused by the impact of landing. This section of the roof flipped over as the end shown dug into the earth.

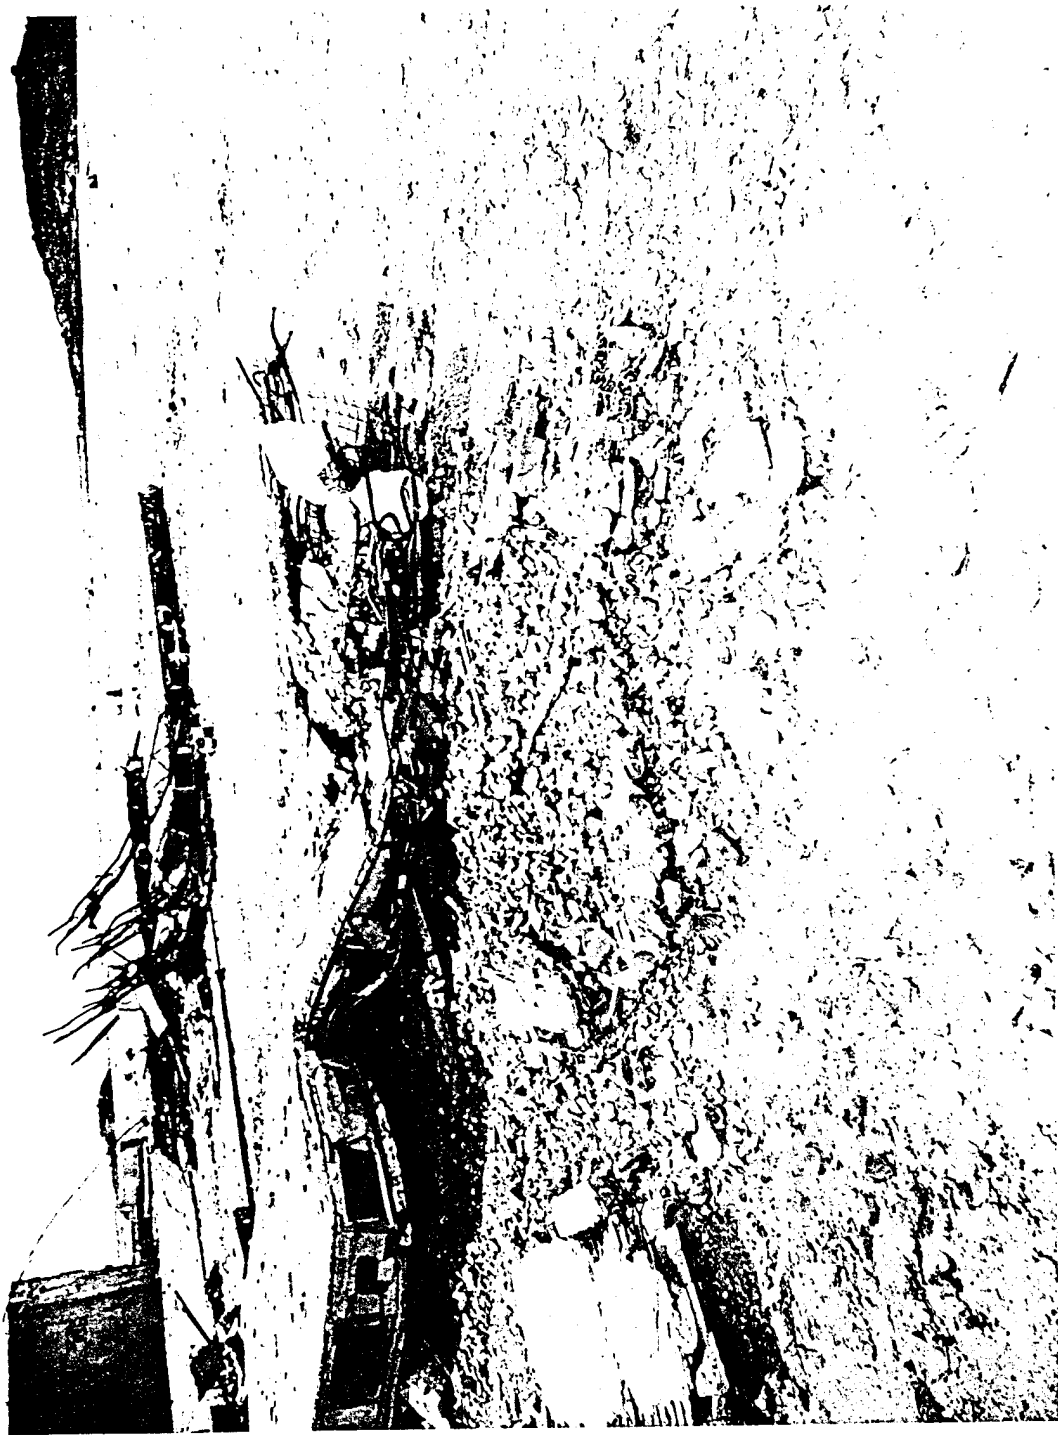
Fig. L. 264 General View of Right Half of Roof, Structure 3. 2. 3b. The left half can be seen in background.

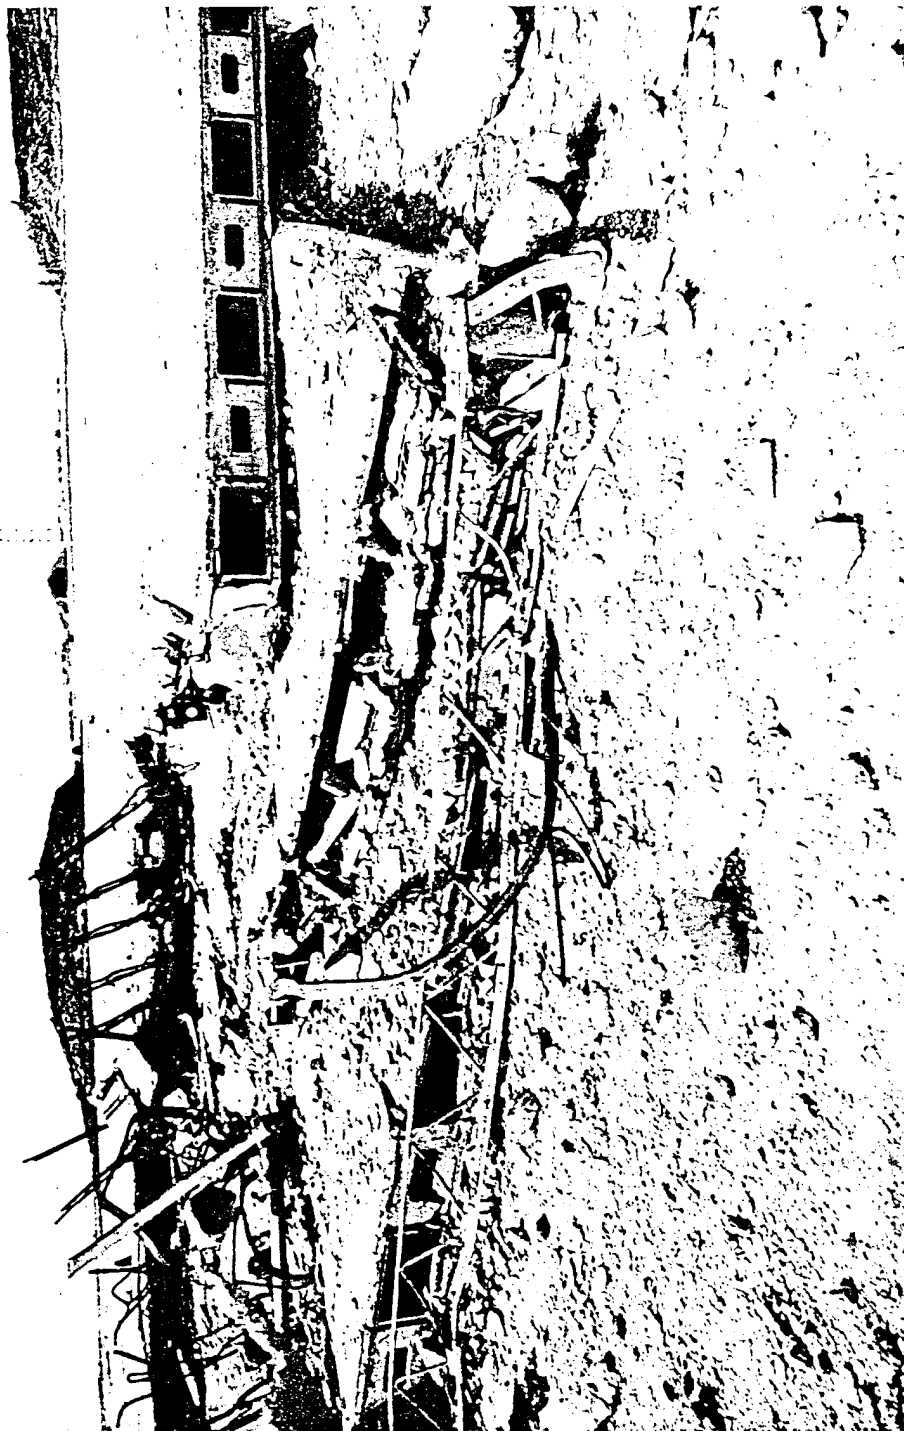
Fig. L. 265 Detail View of End of Roof Panel after Impact Destroyed the Cells and Crushed the Trusses,
Structure 3. 2. 3b

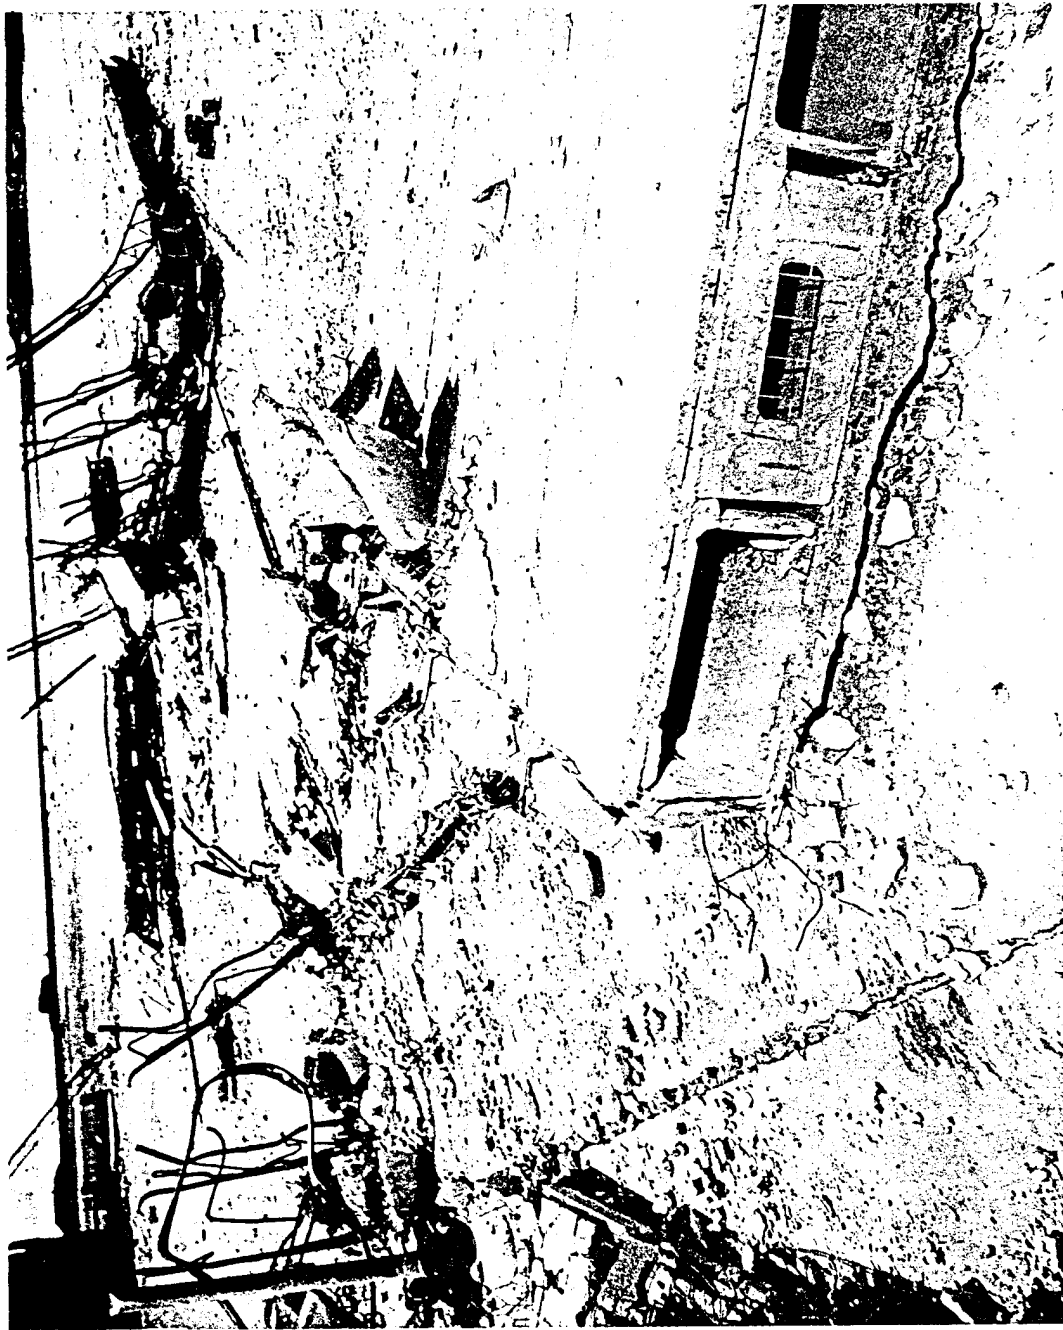
Fig. L. 266 Edge View of Right Half of Roof Section, Structure 3.2.3b. Note how panel of top split along one row of cells.

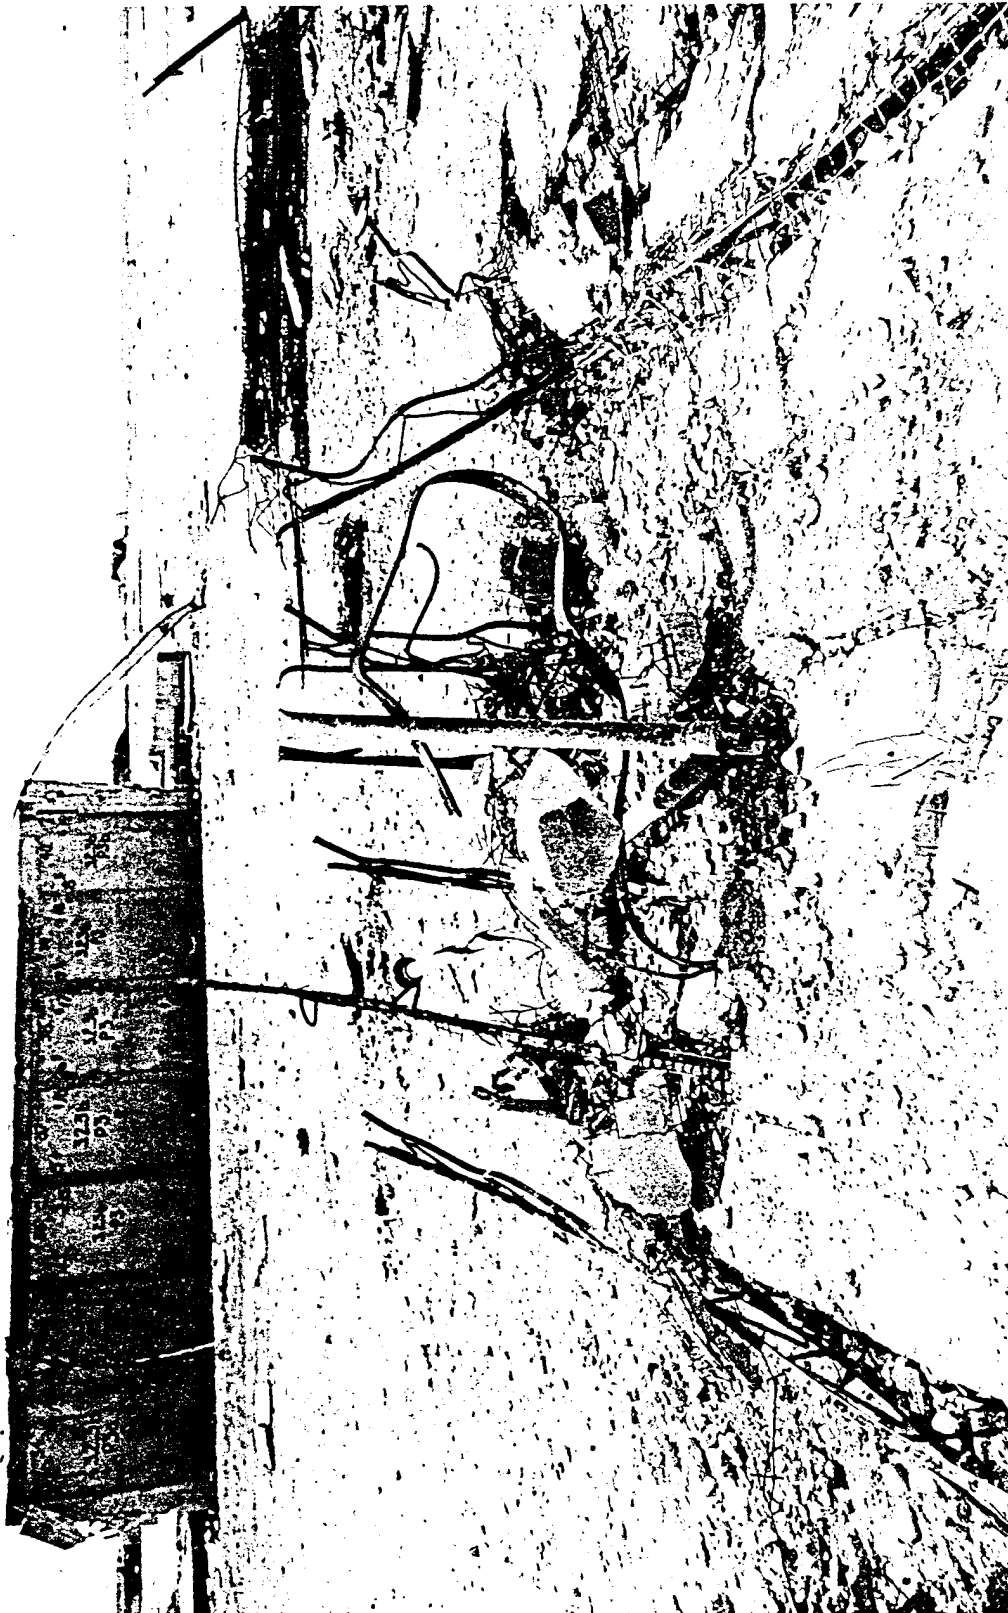
Fig. L.267 Detail View Showing Method of Failure within a Panel, Structure 3.2.3b.

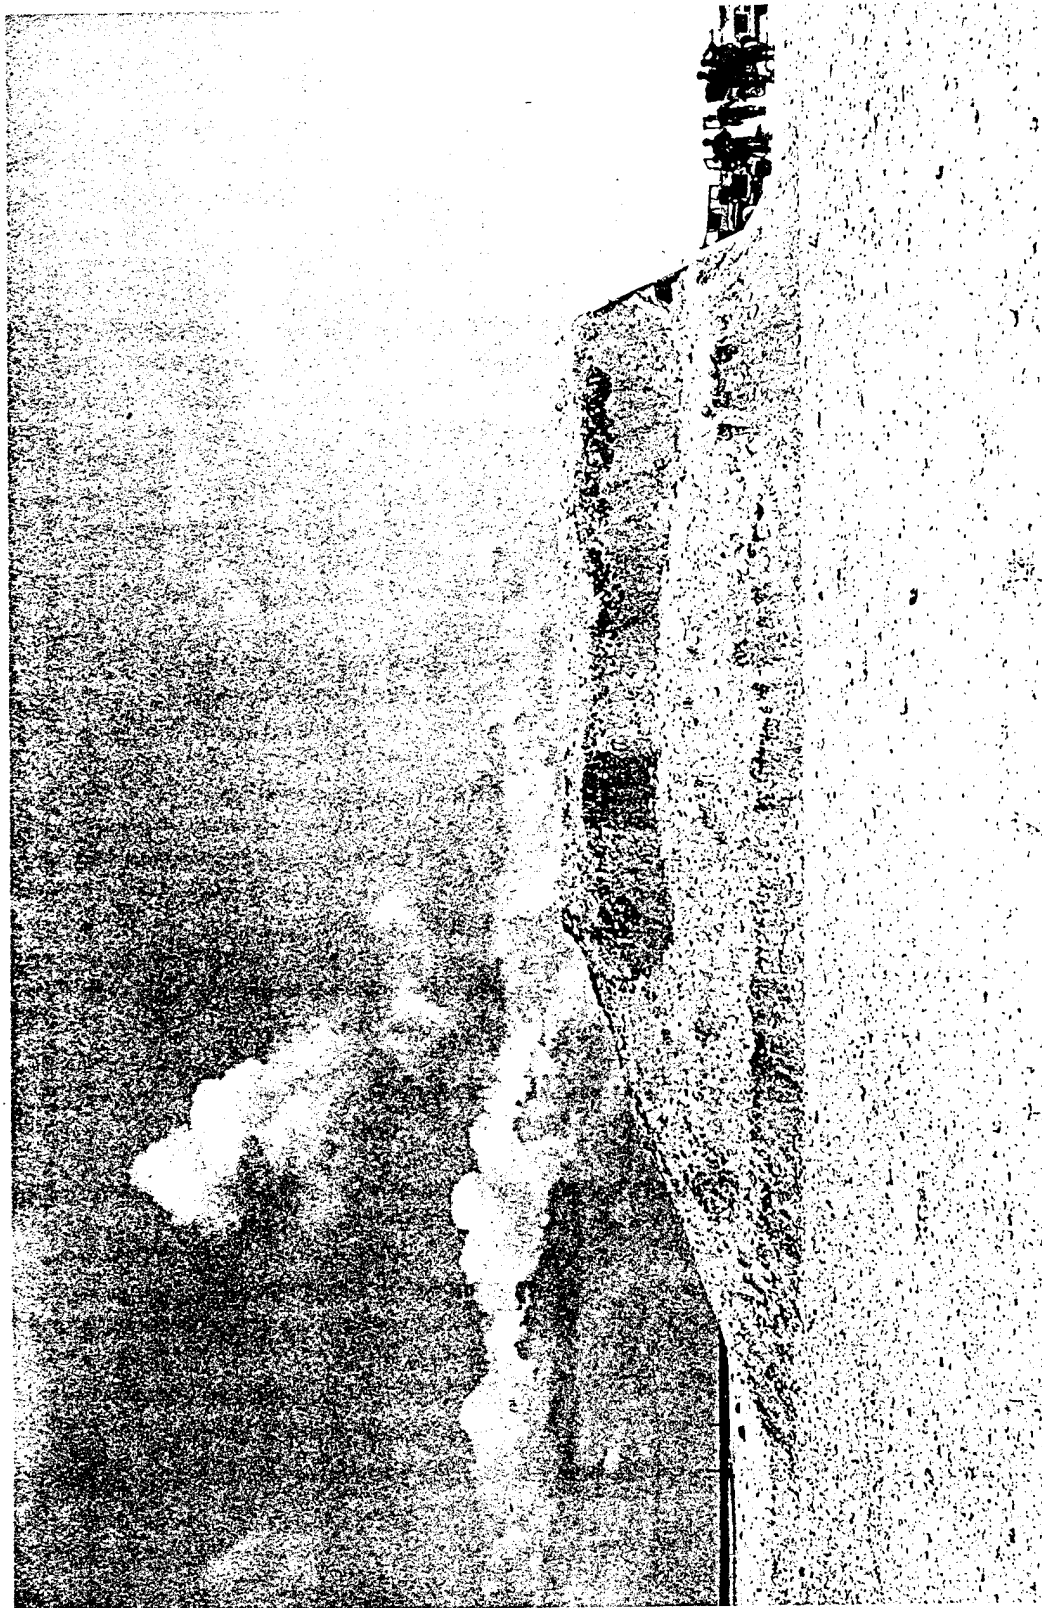
Fig. L. 271 General View from Blast Side, Structure 3. 2. 4a. Little fill was lost from the left slope, but earth cover along main section has been pushed down.

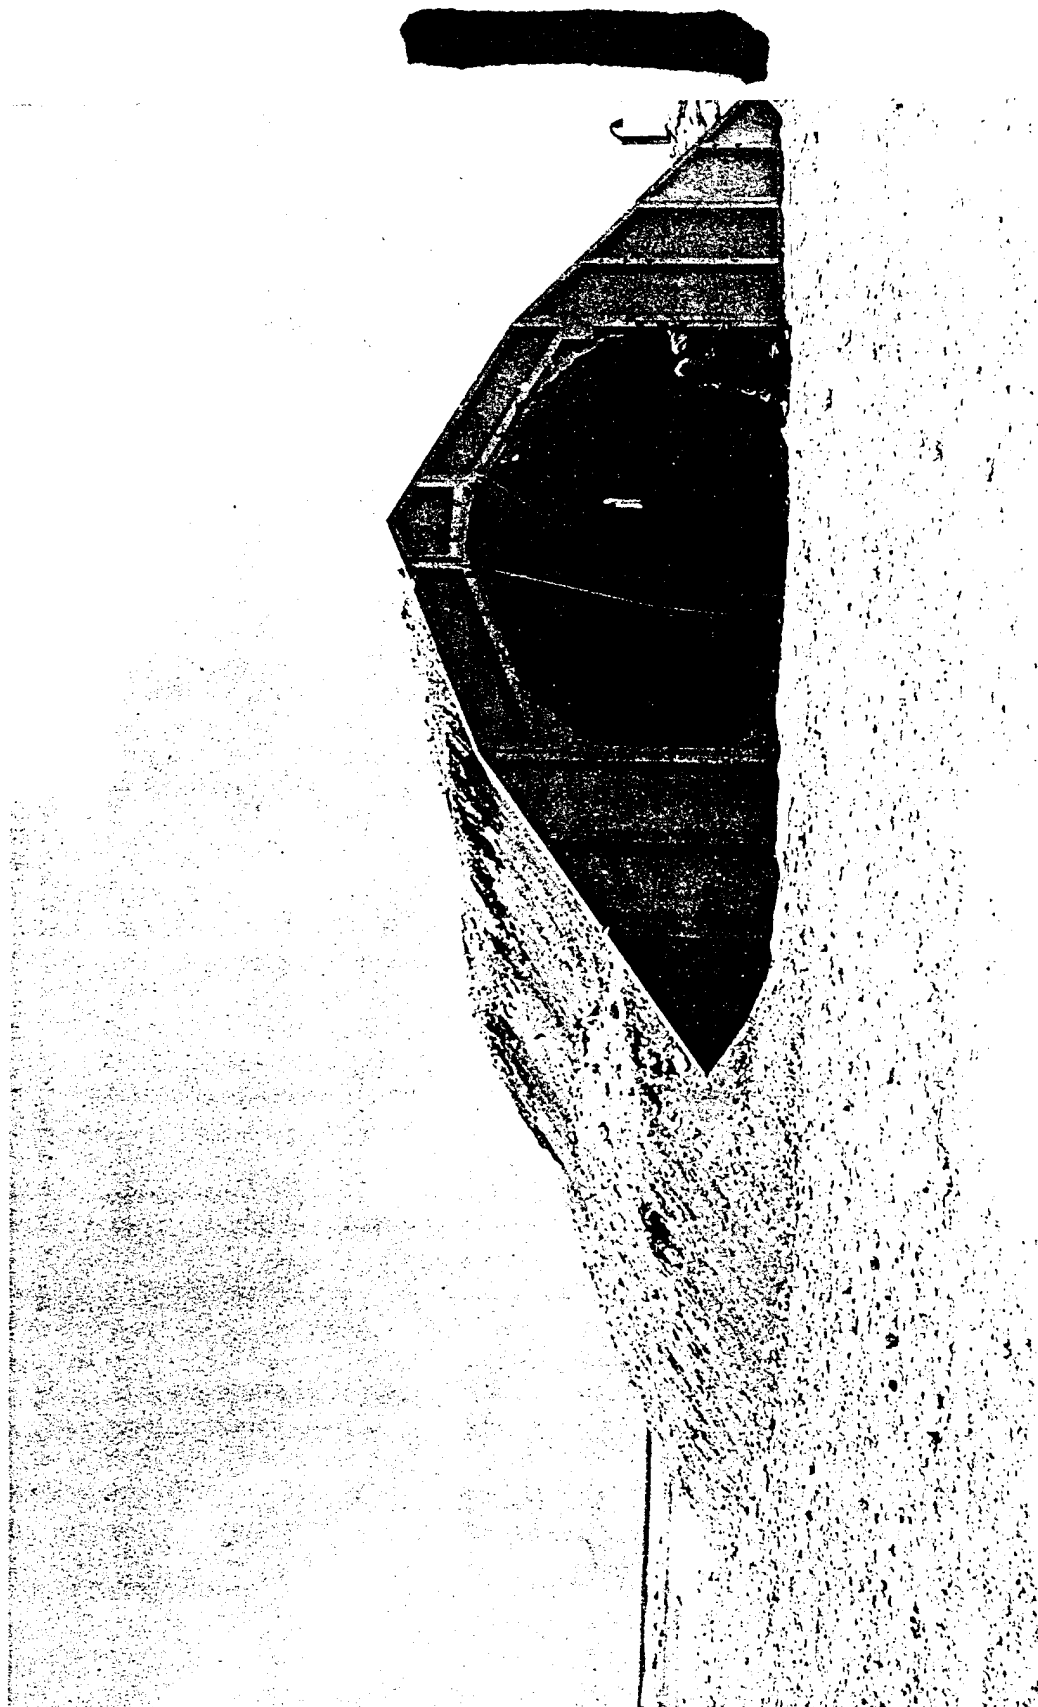
Fig. L.272 General View of Right End of Structure, 3.2.4a. This end wall was blown into the building. Little fill was lost at peak.

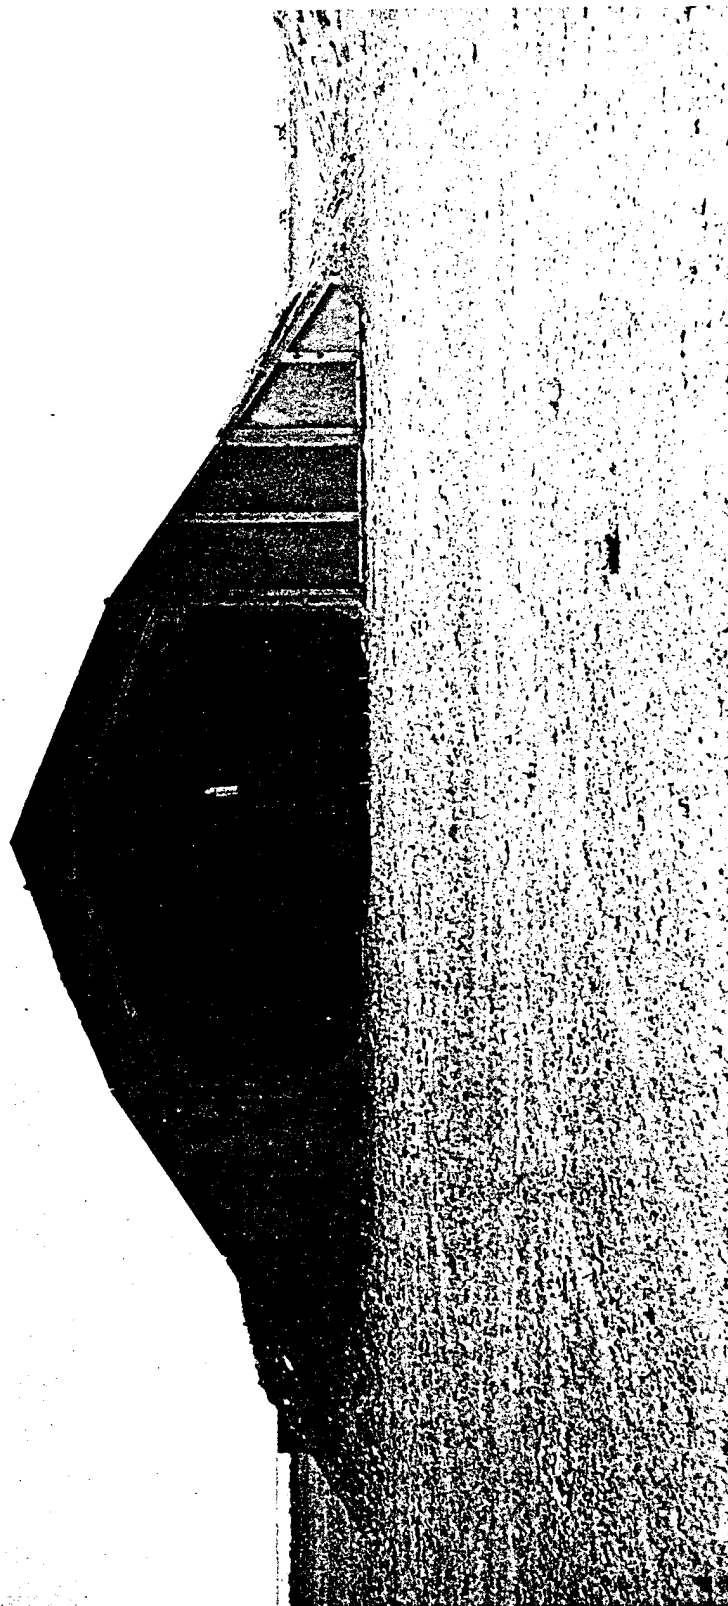
Fig. L.273 General View Normal to Right End, Structure 3.2.4a. Note how earth cover has been forced outward along sides.

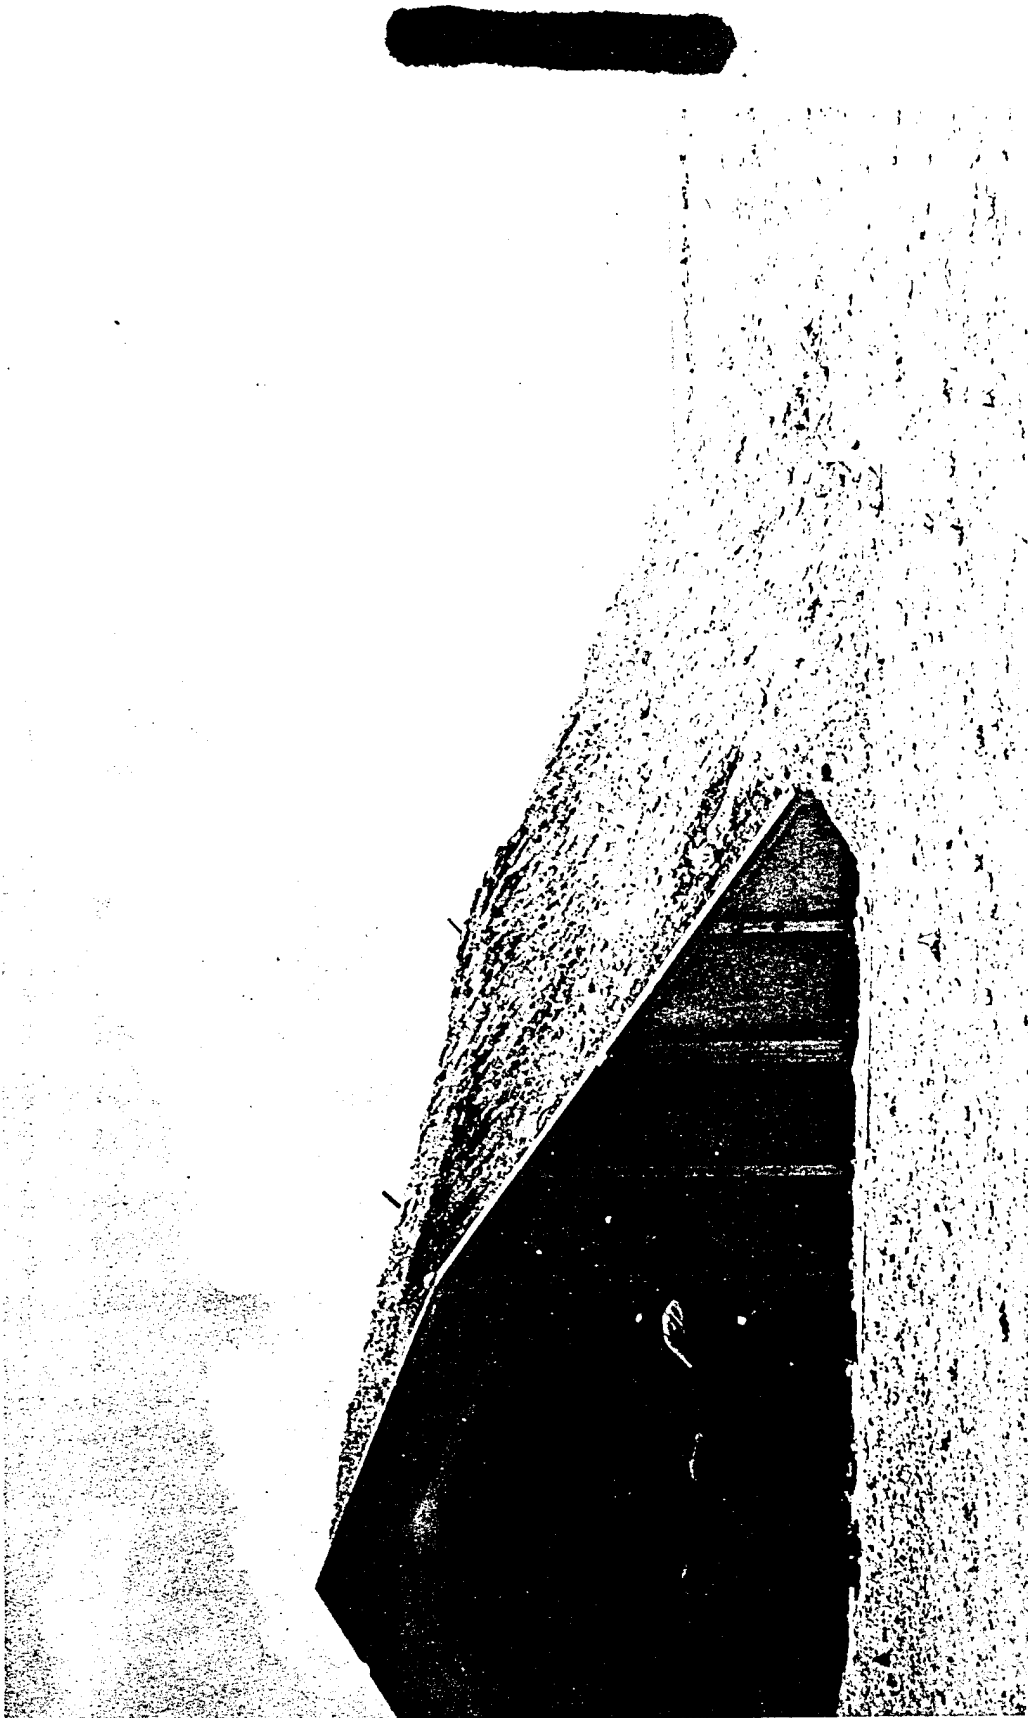
Fig. L.274 General View along Rear Side of Structure, 3.2.4a. Earth cover has not been pushed down as much as it was on the front, but the pattern is similar.

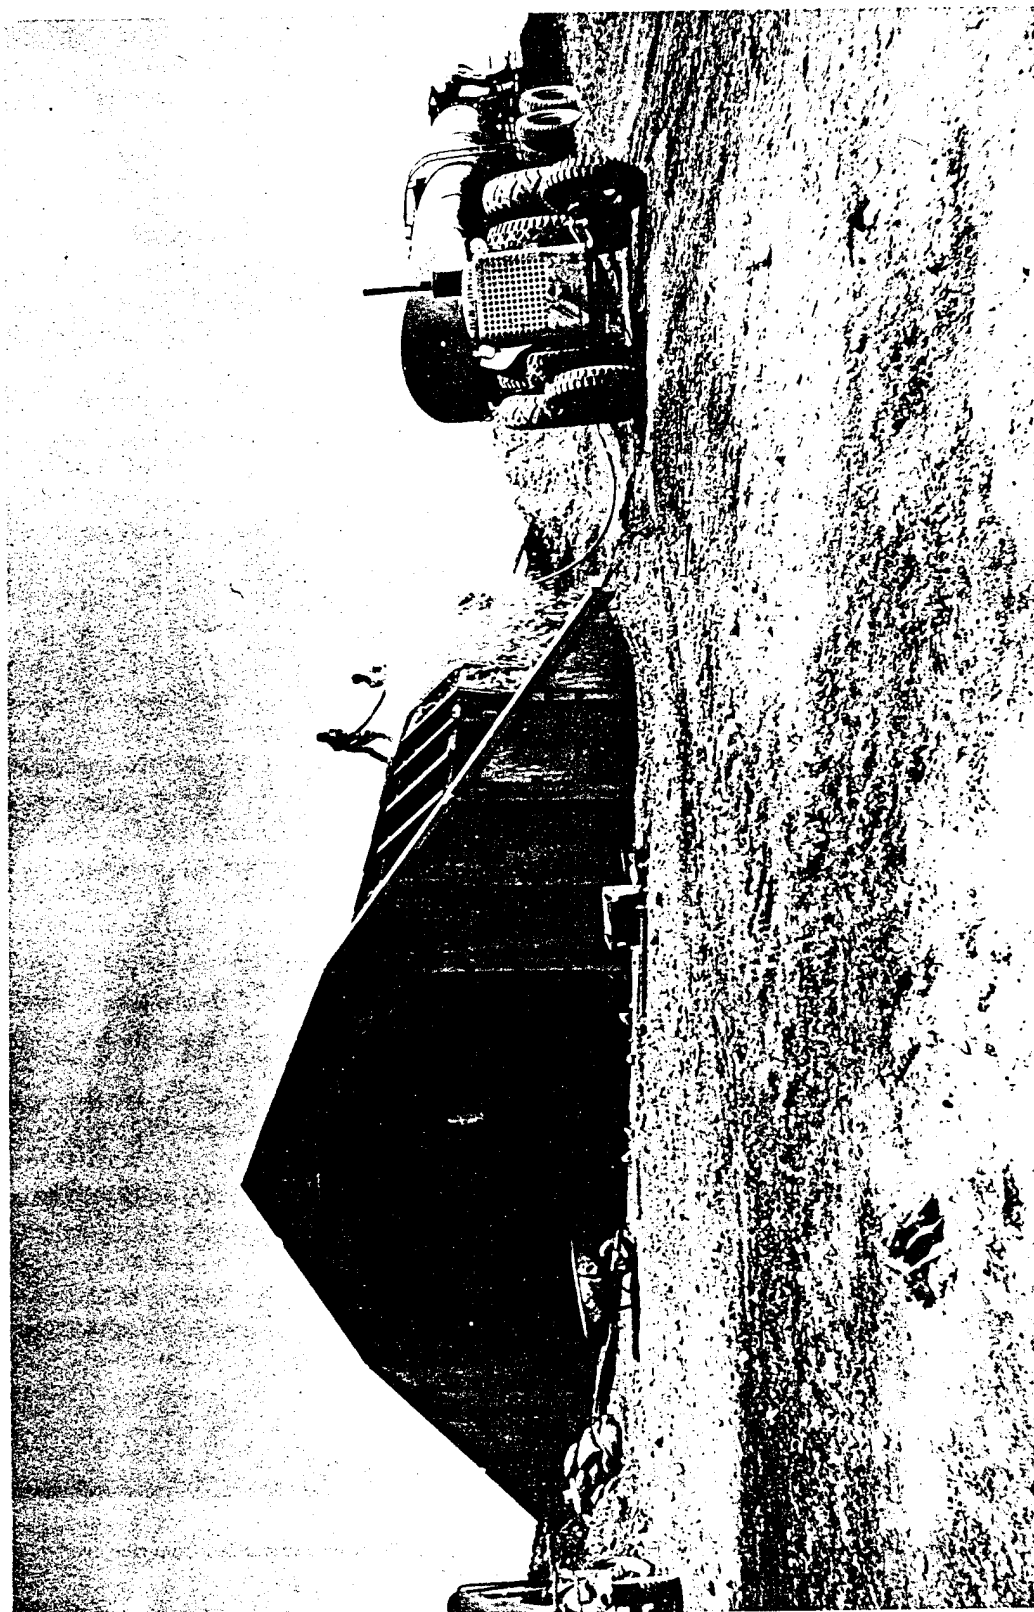
Fig. L.277 General View of Right End of Structure, 3.2.4a. Note earth cover being washed off with high-pressure water stream.

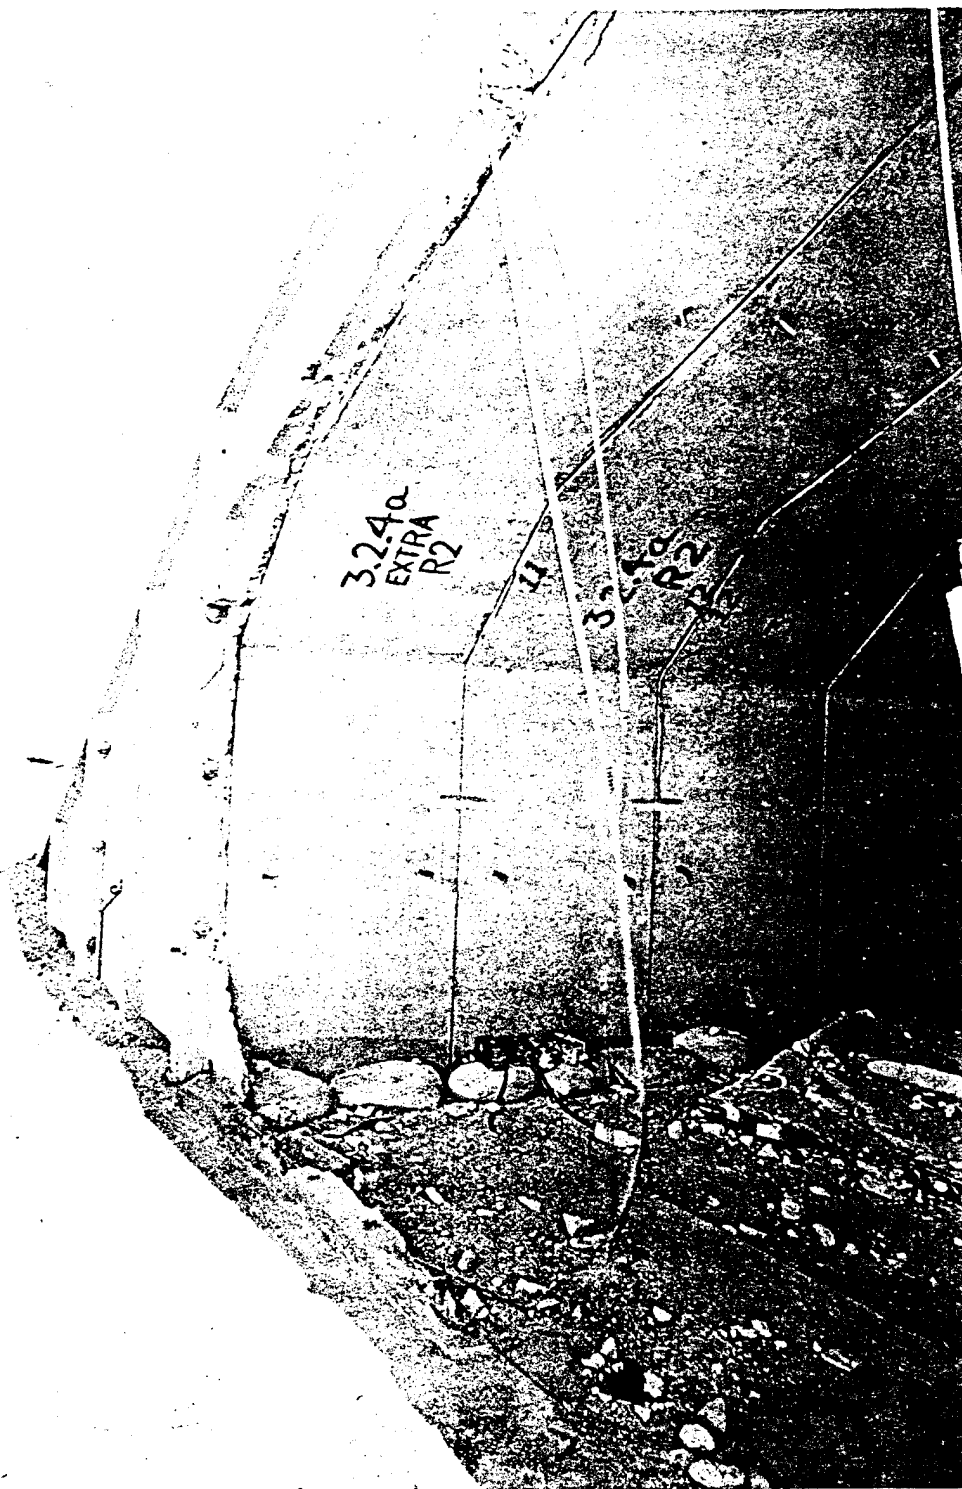
Fig. L. 278 Detail View of Front Portion of Right End of Structure, 3.2.4a. Steel bars suspended from ribs overhead are only remains of end panel. Note the clean lines of cleavage.
